AI - V - A - 014
Graham's Mansion
Wright's Crossing

State Historic Sites Inventory Form

historic Graham Mansion (preferred)

name/title Orlando Ridout Vorganization Maryland Historical Trust date October 26, 1982street & number Shaw House, 21 State Circle telephone (301) 269-2438city or town Annapolis state Maryland 21401

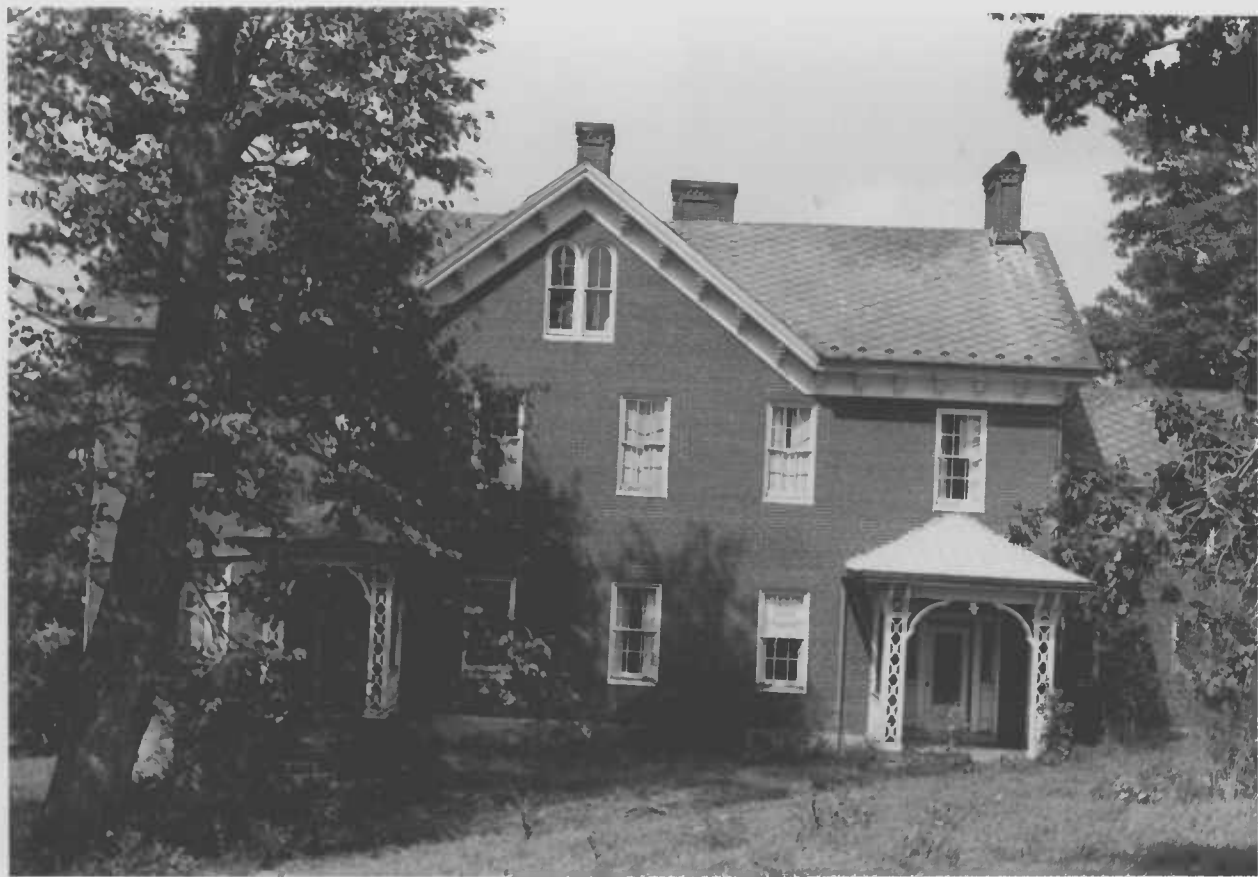
Front (south) Facade; Main House

The principal facade of the main house faces south. It is six bays wide, with the principal entrance located in the east bay of the first floor and a second entrance in the second bay from the west. The four remaining first floor openings are fitted with 6/6 windows; there are six 6/6 windows ranged across the second story. A large cross gable is centered on the middle four bays of this facade, with paired segmentally arched 4/4 windows in the center. A large cellar entrance is located at the west end of this facade; three small window openings pierce the foundation. The stone foundation has been rendered with stucco and scribed with imitation joints. The brick facade is laid in six-course common bond with splayed brick jack arches above the openings. The entire house was at one time painted red with stenciled mortar joints, as indicated by traces of this finish where the walls have been protected by the two front porches and a demolished rear porch. The principal door in the east bay is framed with sidelights and transom and is protected by a handsome one story hip-roofed entrance porch with elaborate Victorian supports, balustrade and bracketed cornice. A stone mounting block for carriages is located directly in front of this porch. The secondary door to the west has a transom but no sidelights and is protected by a similar but slightly smaller entrance porch. This porch has a flight of granite steps and a handsome original iron rail. The roof of the house is covered with diamond pattern asbestos tiles and is surmounted by five decorative Victorian chimneys. The eaves oversail and are boxed in with a bold crownmold applied to the fascia and scrolled brackets below the soffit applied against a wide, plain frieze.

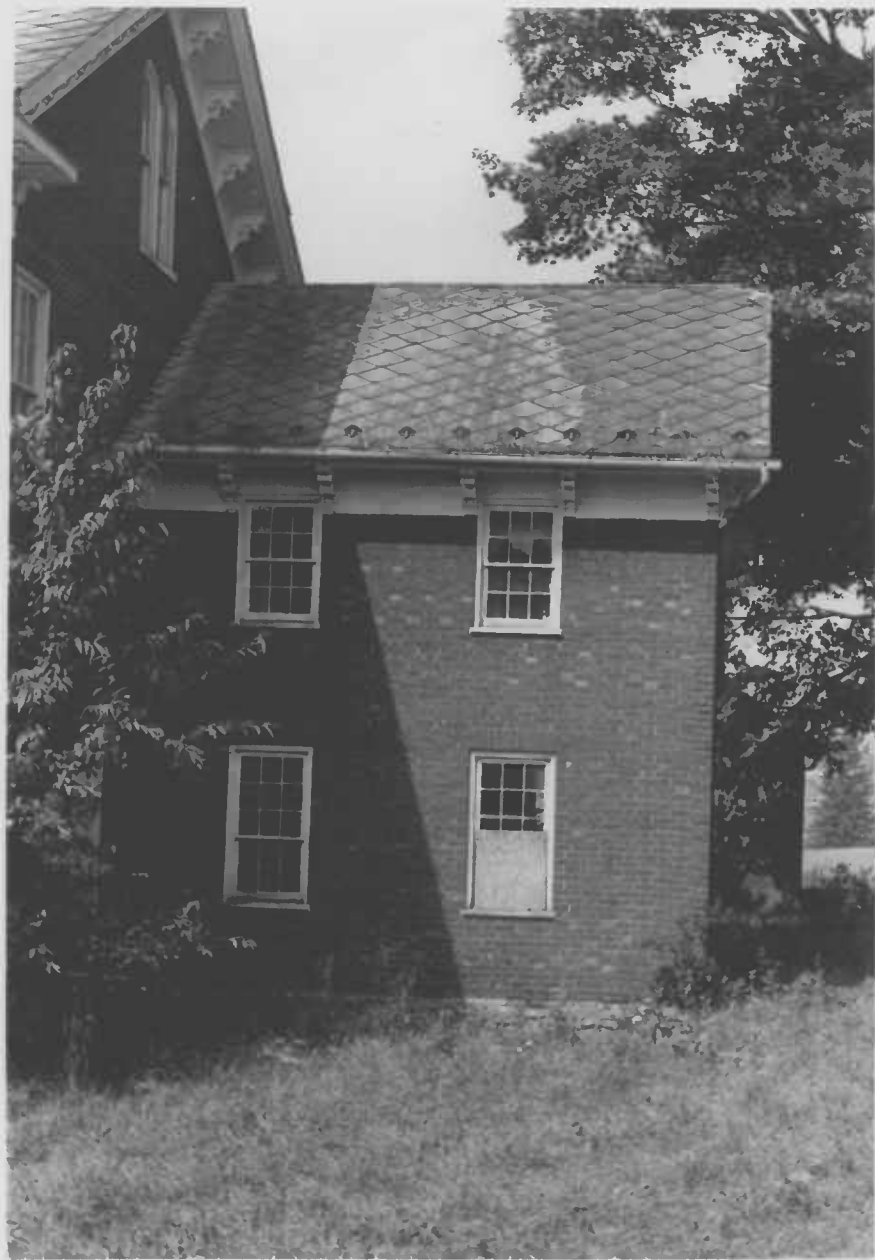
South Facade (c. 1830 orig.)

The south wall of the wing is the principal facade of this early structure. It is constructed of carefully laid Flemish bond brick with numerous randomly placed glazed headers above a fieldstone foundation. There are two 9/6 windows with splayed brick jack arches on the first story and two 6/6 windows without jack arches on the second story. The eaves were rebuilt in 1871 and now consist of a plain box cornice supported by scrolled Victorian brackets matching the main house. The top six-courses of brickwork have been painted to imitate the plain frieze on the main house.
